SERVICE DATA

REPAIR DATA

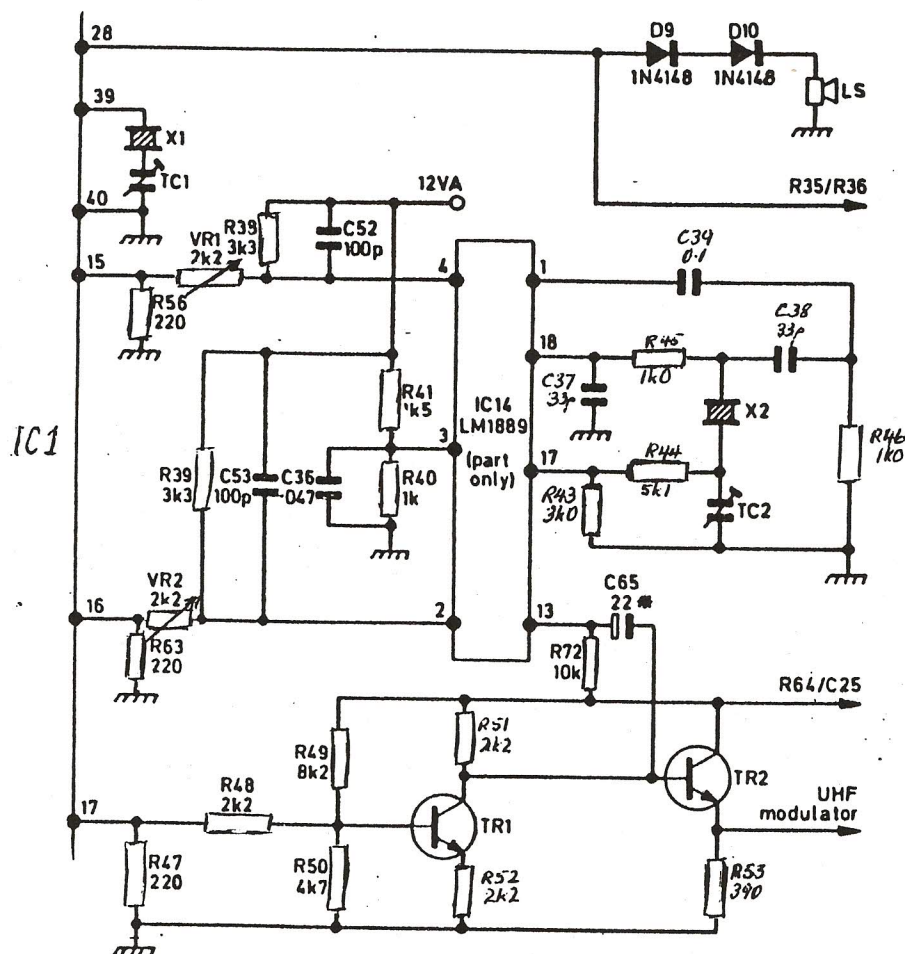
Early circuit showing presets TC1, TC2, VR1 and VR2 to match the early type boards.

Note:- the different pins 16/17 setup from IC1 in the generalised circuit diagram shown in the middle pages.

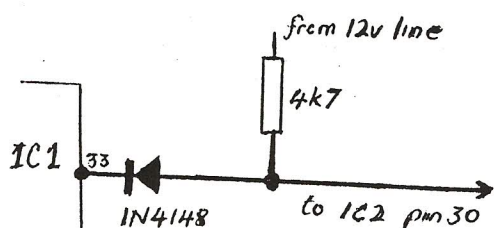
In very versions, instead of TR6 a somewhat unreliable, resistor/diode was used which should be modified as shown in the centre pages.

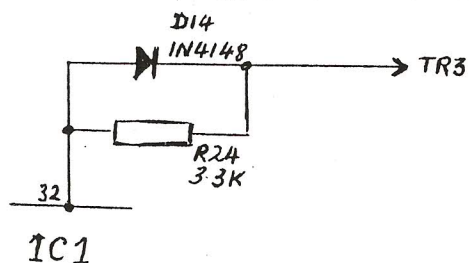
This very unreliable circuit was used in very early versions from pin 32 to base of IC1. This circuit should be modified to that shown in the centre pages if not already done.
