SERVICE DATA

REPAIR DATA

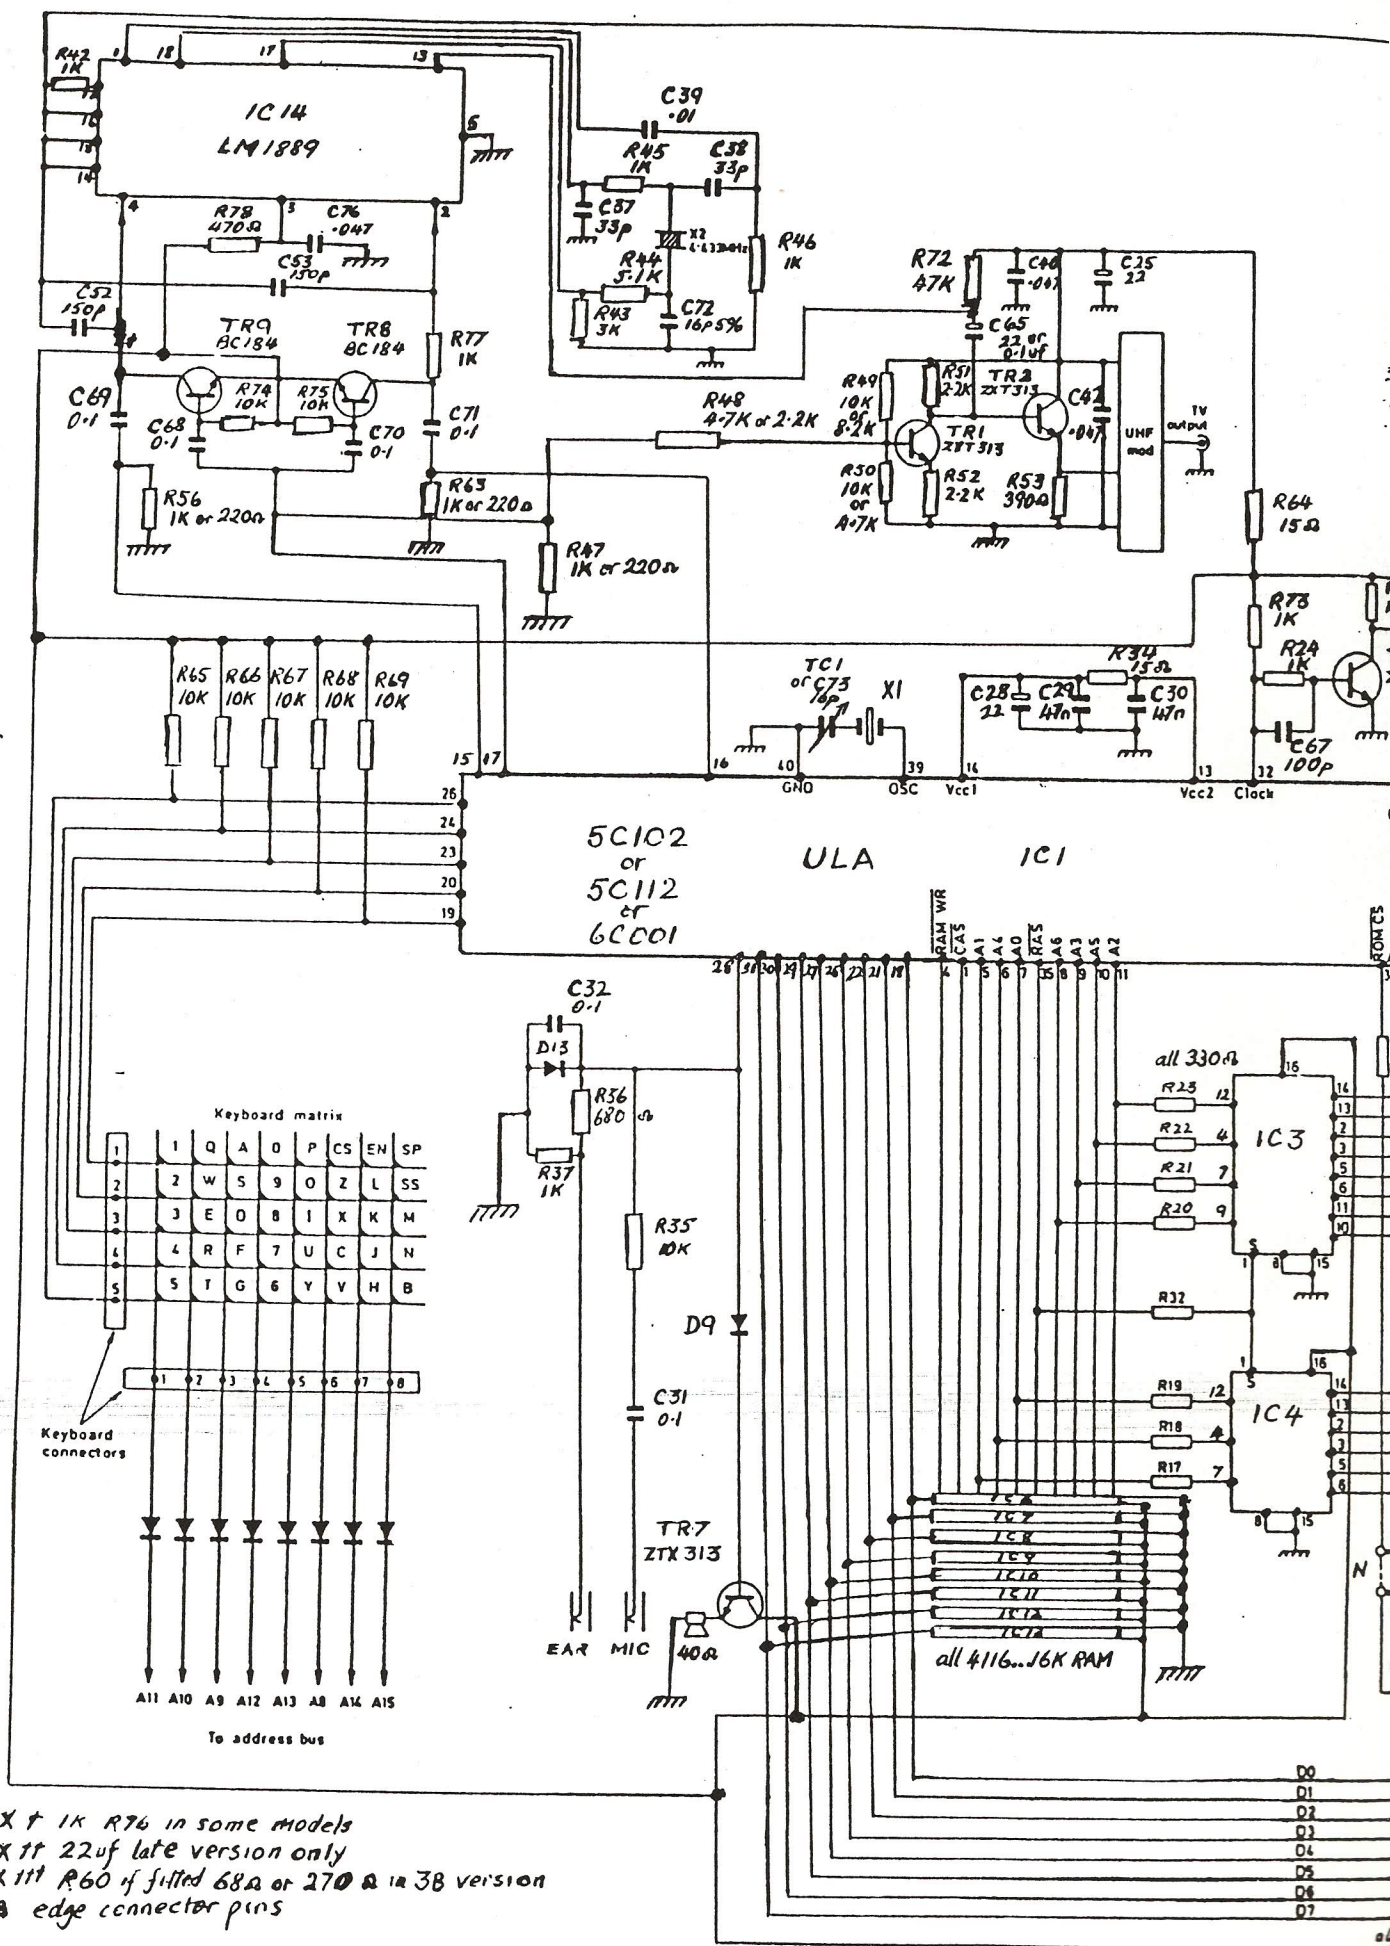
Early circuit showing presets TC1, TC2, VR1 and VR2 to match the early type boards.

Alignment: Only needed for early models. Place meter on pin 4 of IC4 and adjust VR1 to obtain 130mV; adjust VR2 to obtain -75mV at pin 2 with a 20mV allowable error either way. Use TC2 to set colour subcarrier frequency to 4.433619MHz to 50Hz either way. TC1 only helpful to improve screen colour pattern.
