Scotrail - D of S & TE		
Systems Engineering		
Title Video Relay Delay Card		
Size B	Document Number 91SES1.p	Rev
Date Wednesday, November 01, 2006	Sheet 1	of 1

Scotrail - D of S & TE	
Systems Engineering	
Title Cardross/Bowling CCTV Video Relay Timer	
Size A	Document Number 91SES1
Date: September 18, 1991 Sheet 1 of 1

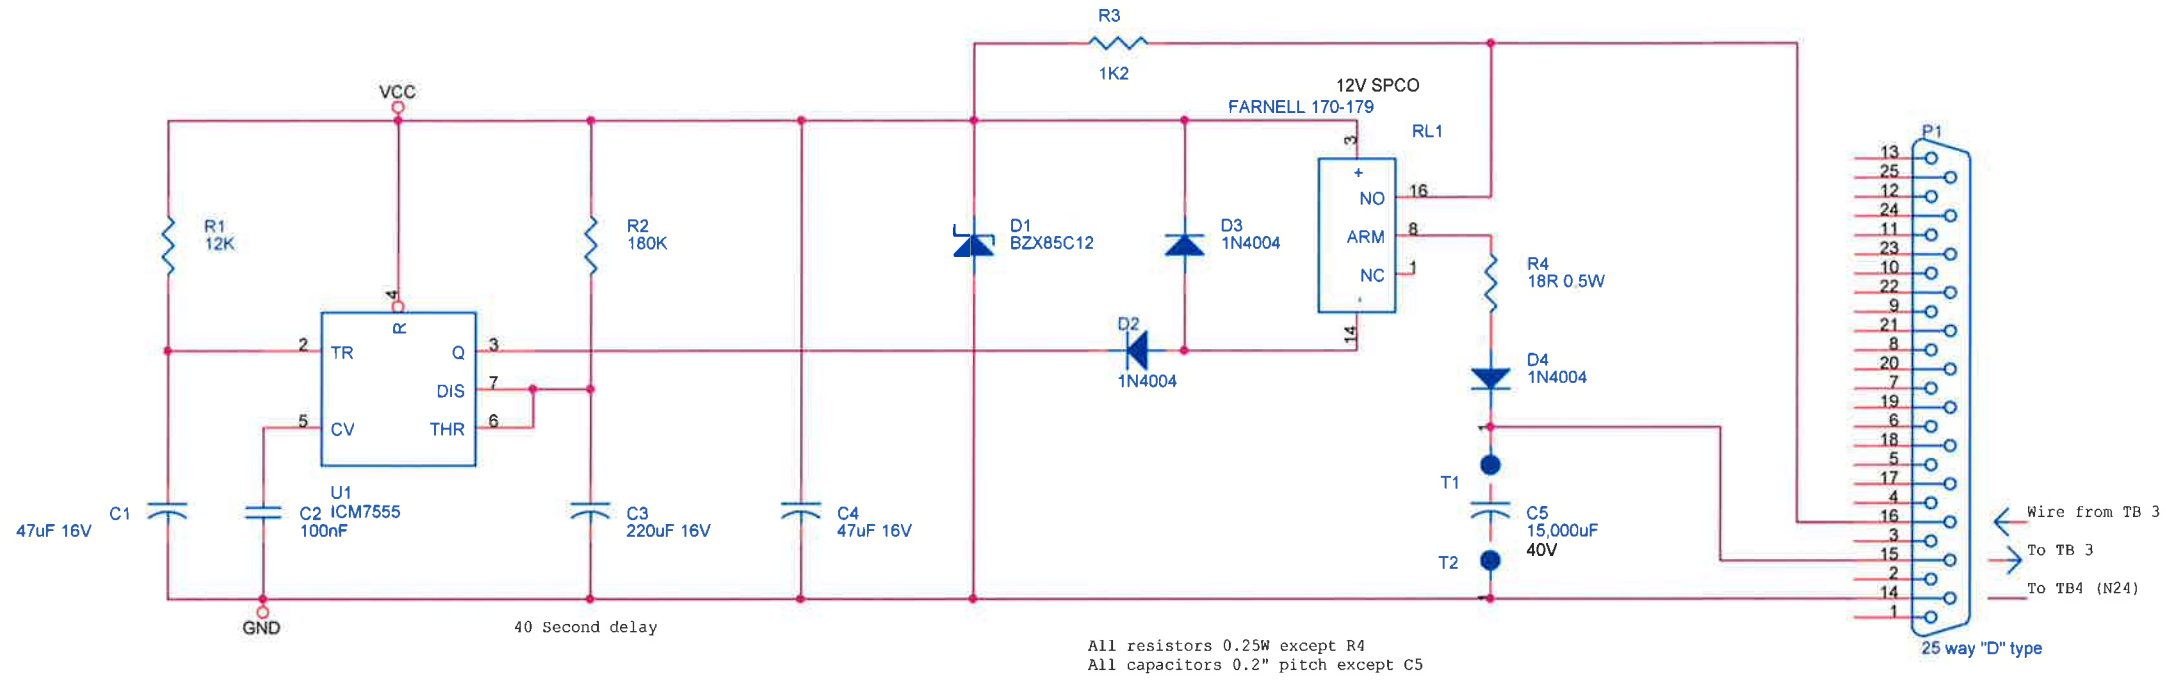
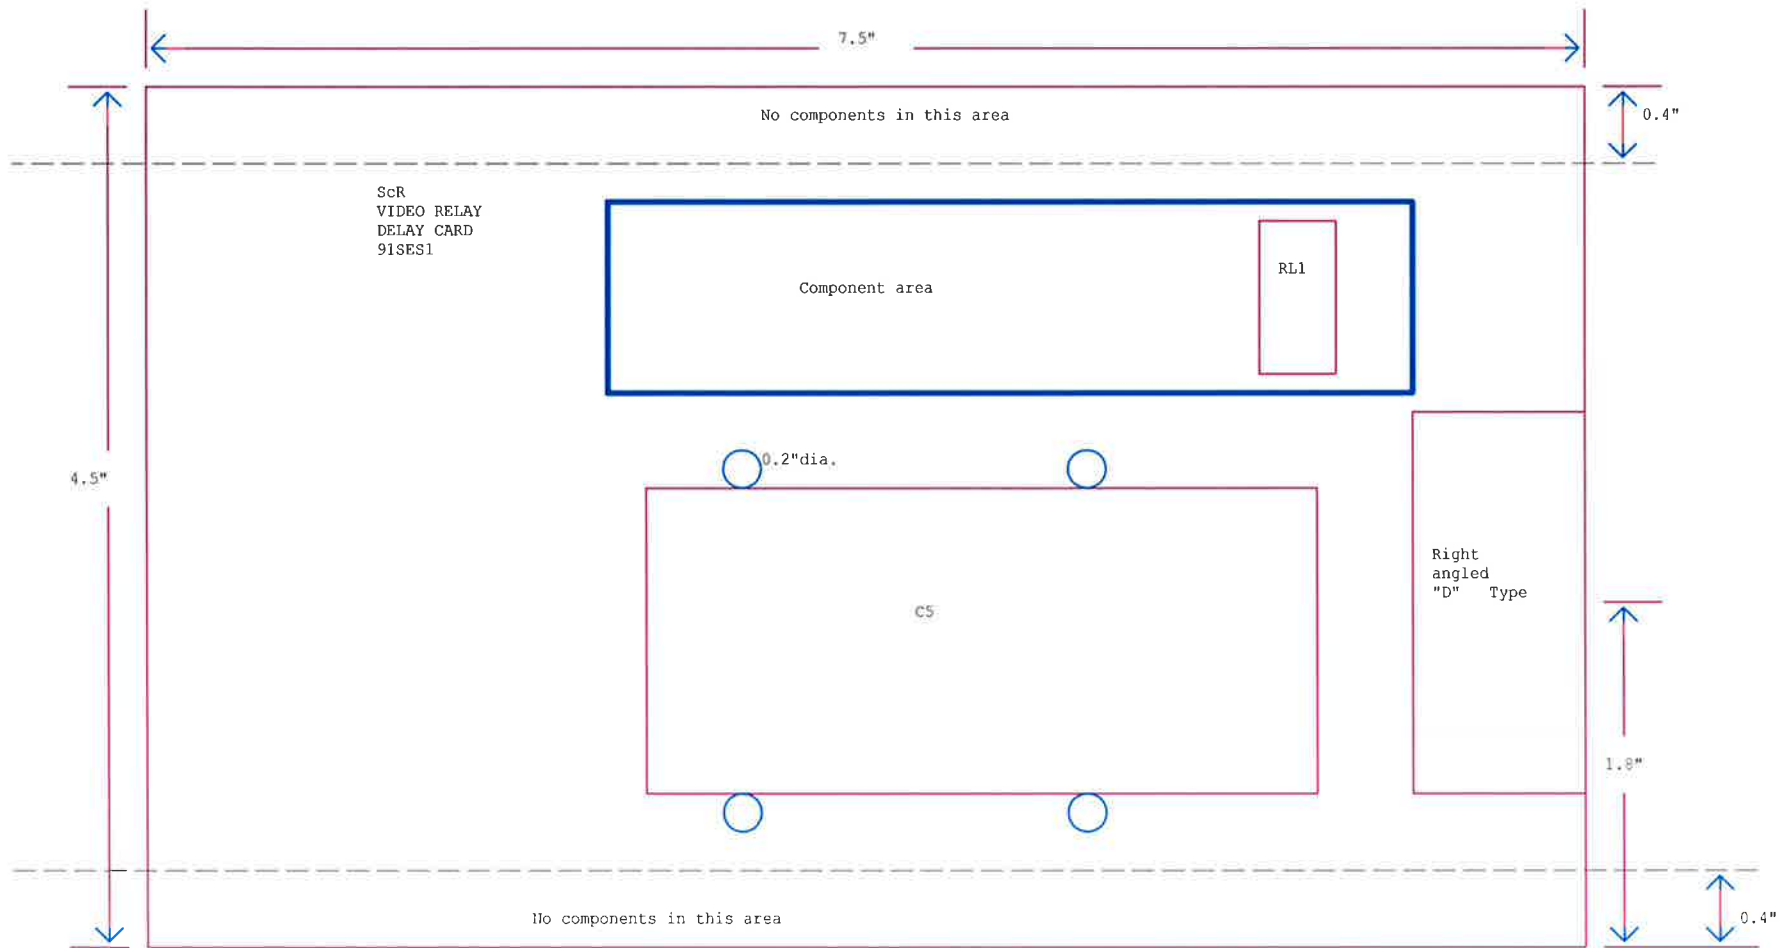
U1 PIN 1 - GND  
U1 PIN 8 - VCC

40 Second delay

- T1 - Wire from terminal 3 of the Video Relay & Test Unit removed and terminated on T1
- T2 - New wire (white) terminated on terminal 3 of Video Relay & Test Unit
- T3 - New wire (black) added to terminal 4 of Video Relay & Test Unit (N24)

This circuit is incorporated in the transmitter card frame because the CODEC transmission system will only accept an accurate 625 line composite video signal.

On camera change over it prevents the video signal from reaching the CODEC until the camera has warmed up and the signal has locked to the mains.
